## REDUCING THE RELIABILITY OF EQUIPMENT AS A RESULT OF THE REDUCTION OF THE CULTURE OF PRODUCTION

*I. Sidorenko, E. Kravtsov, I. Prokopovych, M. Korolkova, S. Dmitrieva. Decreased reliability of equipment as a result of lower production culture.* The study investigates the causes of breakdown of the supporting structure (frame) and transmission elements of the vibratory conveyor, developed by "Sigurd" CJSC (Odessa) and is in operation at one of the enterprises of Ukraine. In result of the studies, the places and nature of destruction were identified, as well as the force factors causing these destructions were calculated. The calculations were carried out at the basis of a calculation scheme compiled by the geometric parameters of the destructible elements of the supporting structure and the permissible stresses for their materials. The calculations were reduced to determining the ultimate forces leading to the destruction of the element and assembly, and their comparison with the effort developed by the transmission. In addition, an analysis of the kinematics and dynamics of the vibration conveyor was made, for which its three-dimensional computer model was developed. Studies we

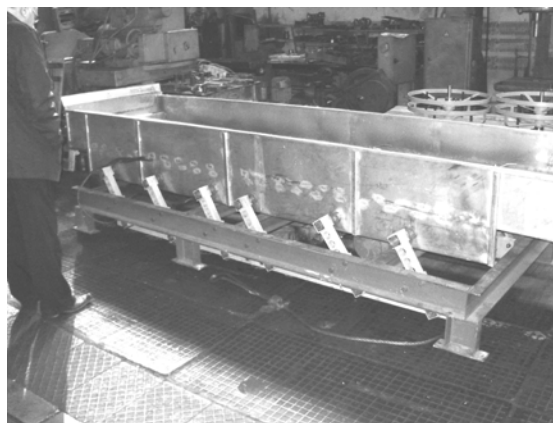
Fig. 1. Vibrating conveyor “Sigurd” CJSC

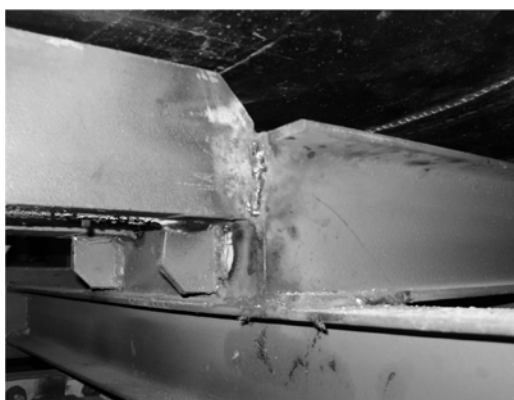
- welded joints of the profile (corner) for fastening the drive elements (connecting rod and engine) with transverse bearing profiles (channel) were destroyed. The presence of the granular structure of the metal at the site of the cut and the absence of traces of rolling suggest that the failure was not fatigue in nature, but was most likely caused by a short-term excess of the allowable load, which led to the destruction of the welds (Fig. 2, a);

*Fig. 2. Places and type of destruction of the supporting structure (frame) of the vibrating conveyor: destruction of the welds (a), destroyed transverse beam of the balancers in the place of attachment of the connecting rod (b); destroyed load-bearing profiles for fastening drive elements (c); numerous fractures and tears of metal (d)*

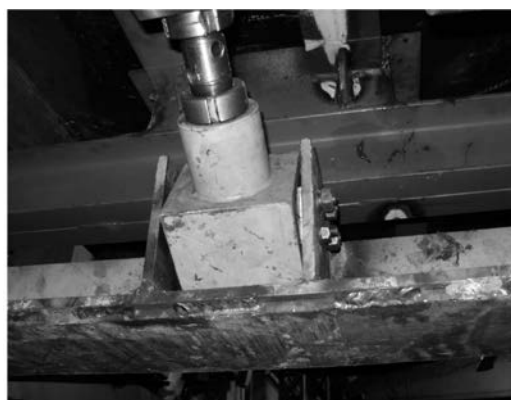
b

- the eye and the transverse beam of the balancers in the place of attachment of the connecting rod were destroyed, the type of destruction is not fatigue, it is likely that the permissible bending stresses are exceeded (Fig. 2, b);

Analysis of the acts of breakdowns available at the enterprise and descriptions of the repair work carried out made it possible to establish the following chronology of real events. The first is the destruction of the transverse beam of the balancers. Repair measures consisted of both a welded joint of the destruction site and the installation of additional linings, which increased the cross-sectional area of transverse beam of the balancer by about 2 times. After the repair work relatively short period of time, the welded joints of the bearing profiles (corners) with transverse profiles (channels) were destroyed. Repair measures in this case consisted in mounting on the damaged element with the help of a welded joint of additional plates and stiffeners. At the same time, the total cross-sectional area ( $A_s$ ) was increased approximately 3.5 times. The repairs also failed. The next day, after it was carried out, the destruction of the bearing profiles (corners) for mounting the drive elements. Repair measures in this case were reduced to installation on a damaged element using welded joint, additional plates and stiffening ribs. In this case, the moment of resistance to bending of the cross section ( $W$ ) was increased by approximately 3 times.

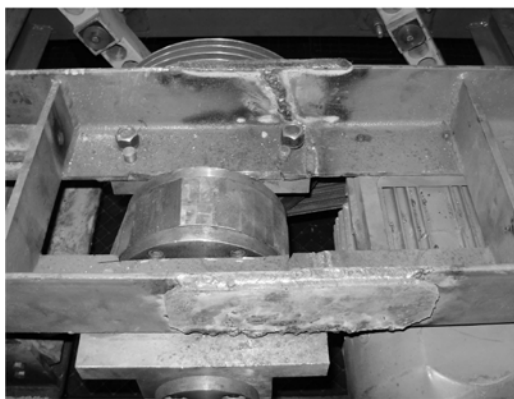
c

- load-bearing profiles (channel) for fastening drive elements (support of the eccentric and engine) were destroyed, the place of destruction was the middle of the span, the type of destruction was not fatigue, bending stresses were clearly exceeded (Fig. 2, c);

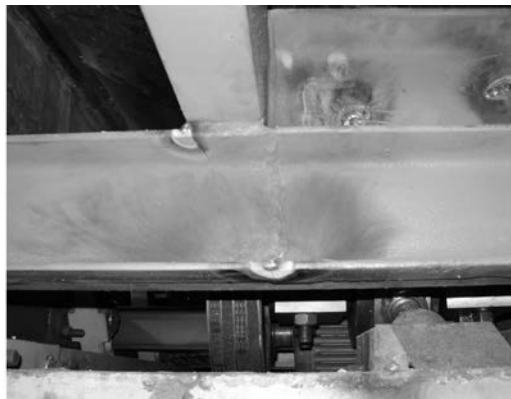
d

- numerous fractures and tears of metal were detected in the supporting elements of the frame - the type of failure is not fatigue, it is obvious that the allowable bending stresses or allowable tensile stresses are exceeded. In some cases, a loss of stability by the profile was observed (Fig. 2, d).

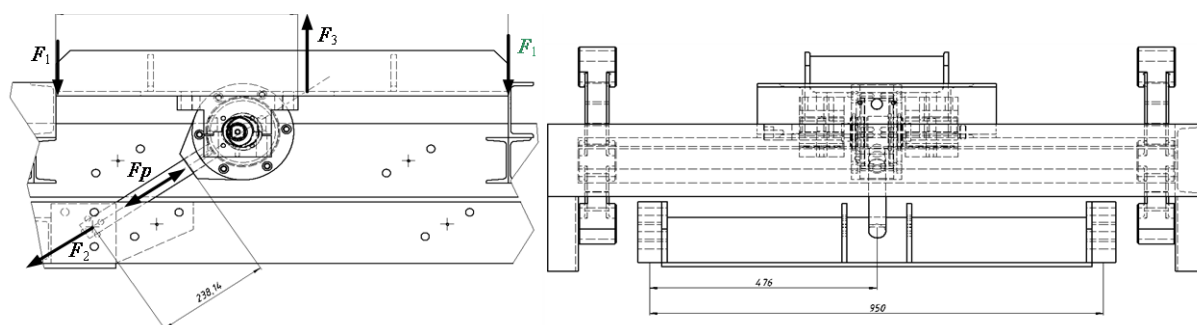
Since the nature and location of the destruction were established, it was proposed to calculate the force factors that cause this destruction, with further clarification of the possible reasons for the occurrence of destruction. Taking into account the presence of geometric parameters of the object under consideration obtained by full-scale measurement, as well as the available data on the materials of its constituent elements, an appropriate calculation scheme was compiled (Fig. 3).

Fig. 3. Design scheme for determining power factors depending on the location and type of damage

Based on the specified calculation scheme, calculations were carried out to determine the ultimate forces leading to the destruction of a particular element and assembly, and their comparison with the installed transmission power. The main calculated dependencies and calculation results are summarized in the table (Table 1).

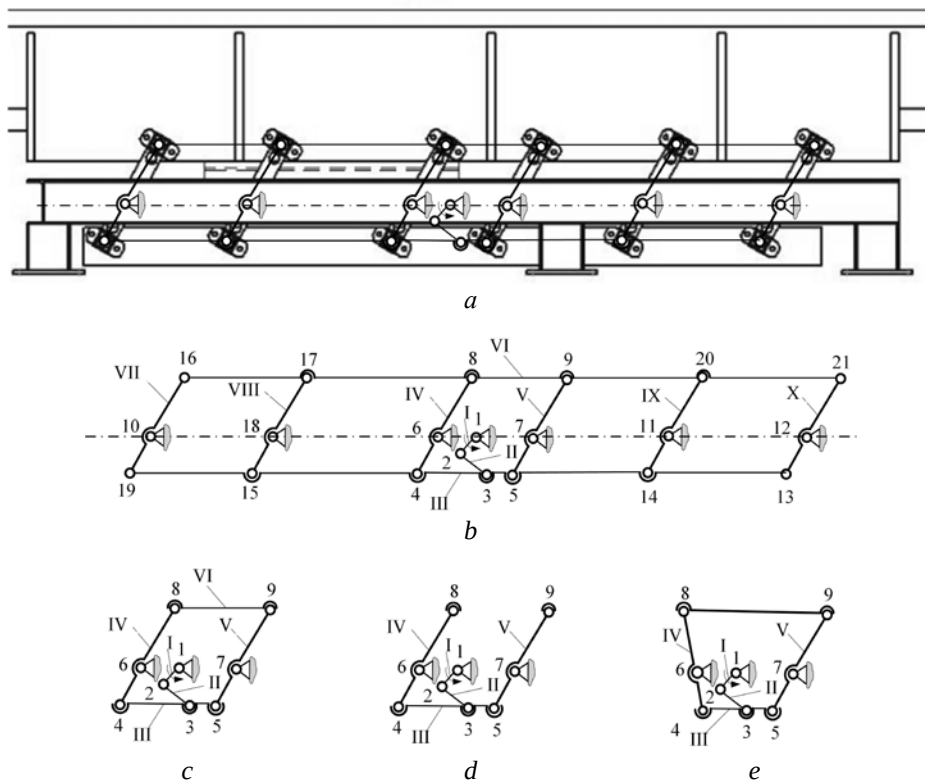
To verify this assumption, a kinematic analysis of the presented vibration conveyor was performed (Fig. 4). A scraper conveyor with a rubber-metal elastic articulated system and a drive with a rigid connecting rod (Fig. 4, a), in accordance with the symmetry condition of the left and right parts of the device lever relative to its longitudinal axis, can be represented by the following kinematic scheme (Fig. 4, b).

Fig. 4. Kinematic analysis of the vibrating conveyor: vibratory conveyor design (a); kinematic scheme (b); generatrix for the kinematic scheme (c); kinematic scheme rational mechanism (d); kinematic scheme “self-blocking” of the mechanism (e)

Given that the kinematic scheme (Fig. 4, c) is the generatrix for the kinematic scheme (Fig. 4, b), we determine the degree of mobility of the latter. Provided that  $n = 6$ ,  $p_5 = 9$ ,  $p_4 = 0$  received:

The equality  $W = 0$  (zero degree of mobility) indicates that the mechanism under consideration is a rigid frame. However, it is not. There is a classic example of a mechanism with excess coupling (excess coupling is a link whose presence or absence does not affect the laws of motion of other links in the mechanism, for example, links I, II, III, IV, V, VI from the rational mechanism (Fig. 4, d). As a rule, excess bond is introduced into the mechanism for structural reasons (in the design of the vibrating conveyor under consideration, the upper hopper is an excess coupling).

Will inevitably lead to the effect of “self-blocking” of the mechanism, that is, to its transition after selection of the gaps to the state corresponding to a rigid frame (Fig. 4, e).

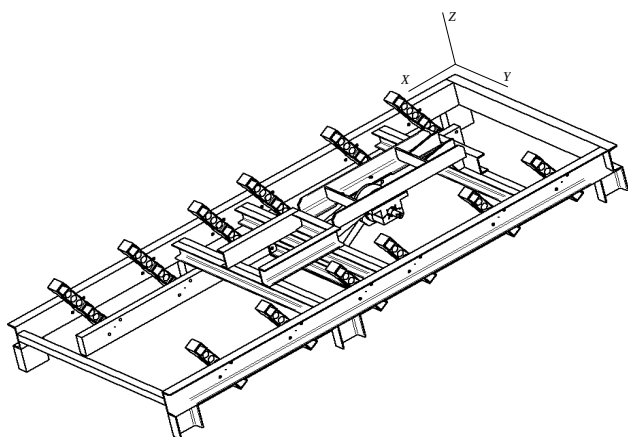
To check the kinematics and dynamics of the vibrating conveyor according to the drawings provided by “Sigurd” CJSC, a computer three-dimensional model of the device frame was created in the CAD environment of Autodesk Inventor (Fig. 5). Using Autodesk Inventor dynamic modeling tools (Dynamic Simulation), we modeled the workflow of this device, which allowed us to establish the following:

- violations of the geometric parameters of structural elements and their connections that lead to “notches” or intersections of parts during operation were not detected;
- the balance of the mechanism is satisfactory, the masses of the counterweights are selected within the tolerance of  $\pm 20$  kg and do not cause significant dynamic loads;
- strength characteristics of structural elements and their joints according to the conditions of exceeding the rated loads and a half times are selected correctly.

Fig. 5. 3D model of the frame of the vibrating conveyor

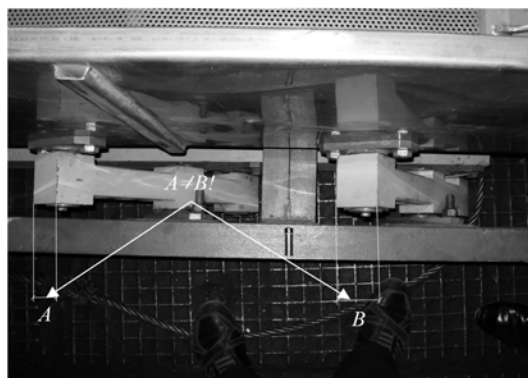
*a*

- the most of the levers of the device are connected to the balancers “in place”, which does not correspond to the places determined by the dimensions in the technical documentation. In this case, the face is not parallel to the leverage (Fig. 6, *a*), which is the main cause of the effect “self-blocking” according to expression (2) and violation of requirements (3);

*Fig. 6. Errors in the assembly of the vibration conveyor leading to the effect of “self-blocking”: end surfaces of levers are not parallel (a); violation of the conditions of perpendicularity of the fixing raft to the lever (b); uneven press of rubber bushings on a symmetrical pair of levers located next to the transverse beam of the balancer (c); traces of slipping of the drive belt (d)*

- a set of measures was taken to improve the quality of assembly of levers and axles with rubber sleeves, as well as the levers of the device with balancers themselves, including the development and use of measuring (calibration) tools and equipment;

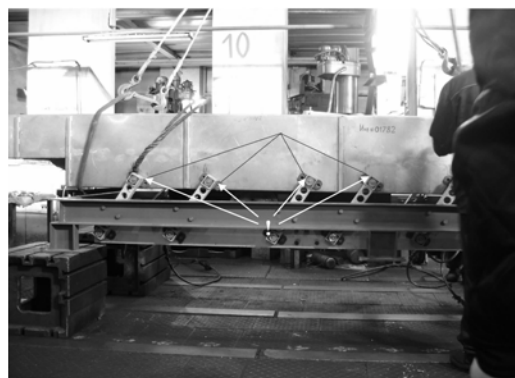
*b*

- assembly of levers and axles with rubber bushings by means of pressing-in was done with violation of the conditions of perpendicularity of the fixing raft to the lever, which is defined in the technical documentation (Fig. 6, *b*). Obviously, this determined the fastening of the balancers “in place” and not in size.

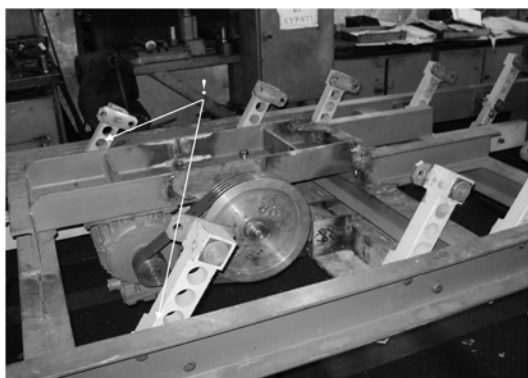
*c*

In addition, in support of the “self-blocking” effect, as the alleged reason for the failure of the presented equipment, it is confirmed by a significant development in the form of punching rubber bushings on a symmetrical pair of levers located next to the transverse beam of the balancers (Fig. 6, *c*). The protective properties of the belt drive against overload (belt slipping took place) were negated by excessive belt tension (Fig. 6, *d*).

- it was recognized to be rational to replace the rubber of the bushings with softer ones, which would allow less effort during assembly by pressing, which, along with the involvement of more qualified personnel, allowed to increase the accuracy of assembly;
